RESEARCH MEMORANDUM

TESTS OF AERODYNAMICALLY HEATED MULTIWEB WING

STRUCTURES IN A FREE JET AT MACH NUMBER 2

TWO ALUMINUM-ALLOY MODELS OF 20-INCH CHORD

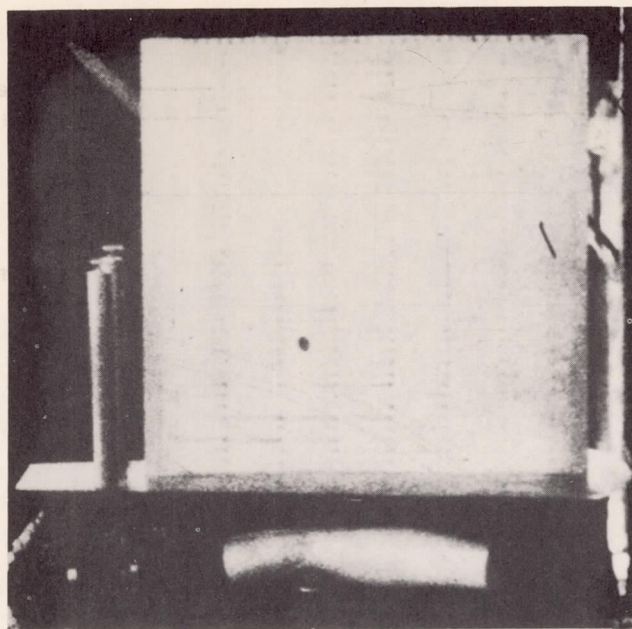
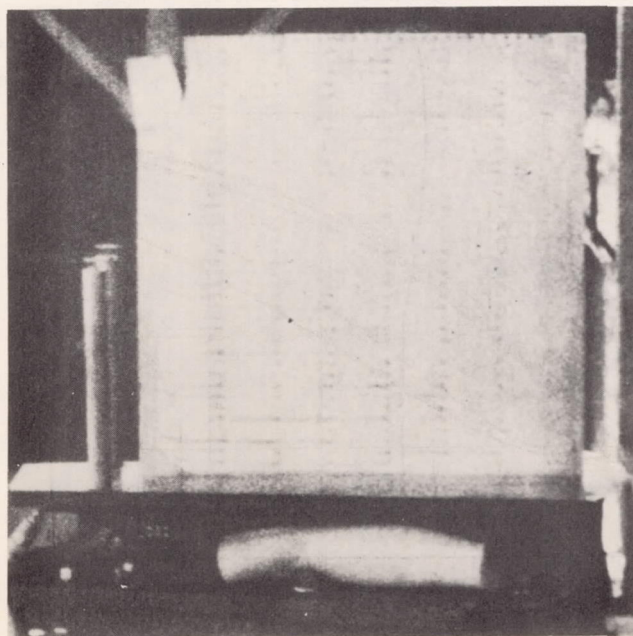
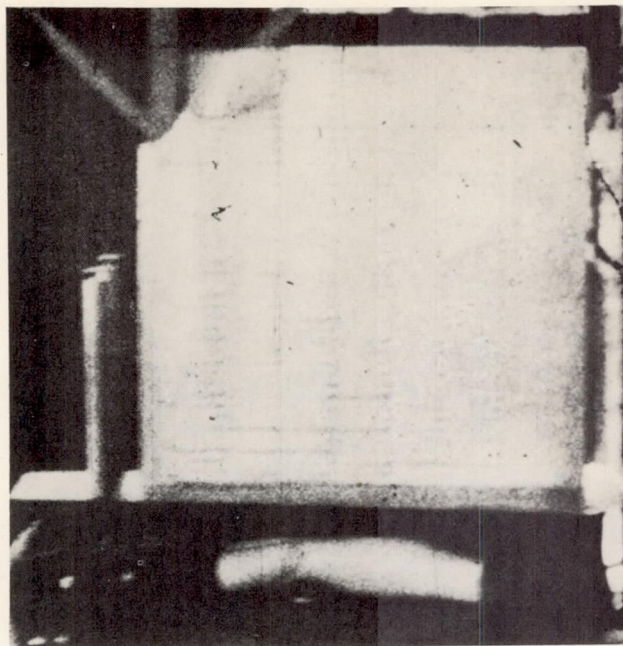
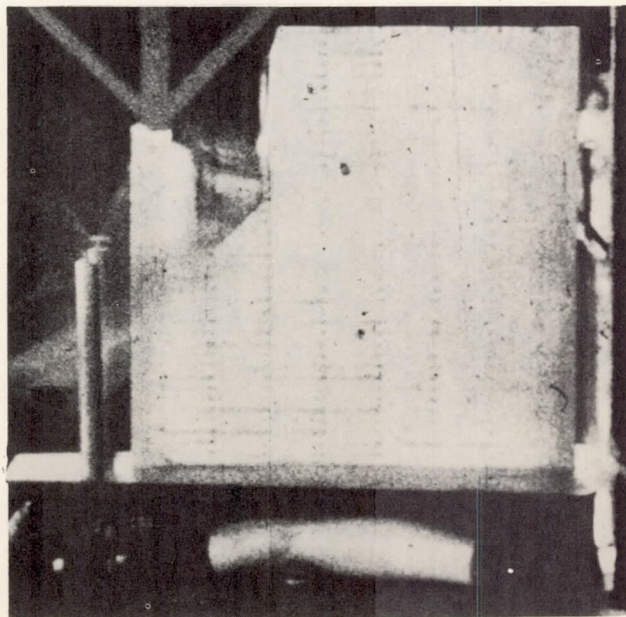
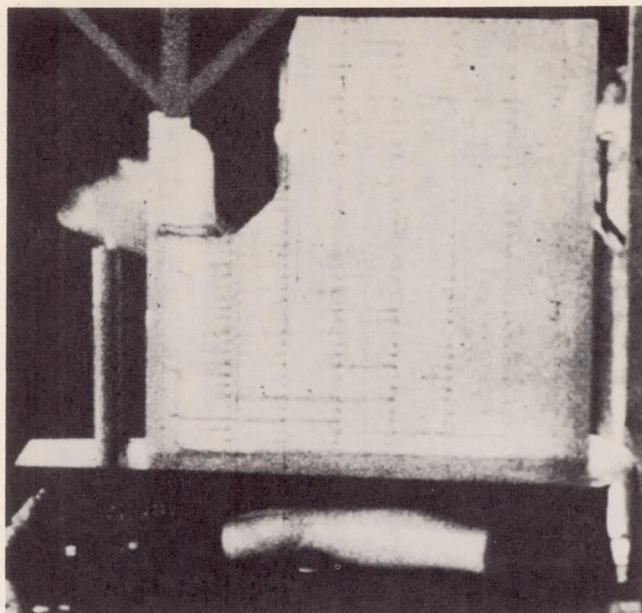
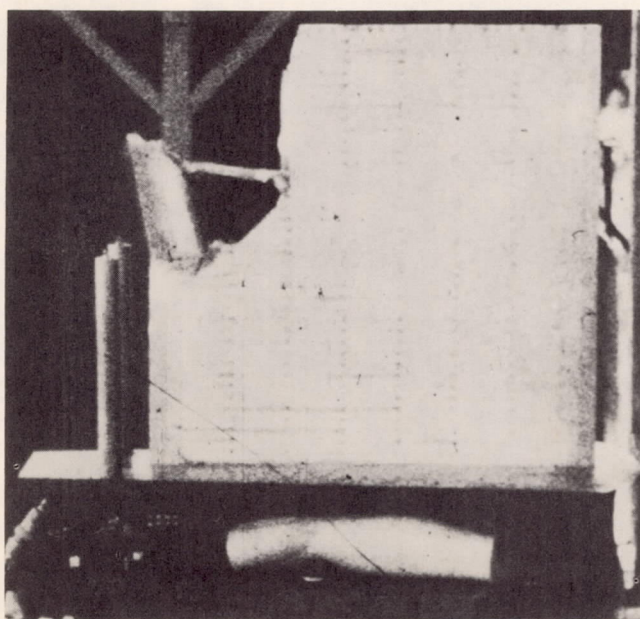
Model MW-2.- After experiencing some random vibrations due to the characteristic initial disturbance of the jet (see the appendix), model MW-2 remained steady until 9.8 seconds. At this time, as indicated by the motion pictures taken by cameras placed above the model and by the frequency, phasing, and amplitudes of the skin strain gages across the chord 11 inches from the tip, the model began to flutter at 226 cycles per second in a mode with about $1\frac{1}{2}$ waves along the chord and with the maximum amplitude near the trailing edge - a flag-waving action involving chordwise bending of the airfoil section that has been called chordwise flutter (refs. 2 and 8). Motion pictures taken from opposite sides of the model indicated that at approximately the same time, 10.0 seconds, a buckle had developed in the rearmost panel of both skins. At 10.8 seconds the stagnation pressure dropped below 100 lb/sq in. abs and test conditions were considered as having ended at this time. Shortly thereafter, at 11.5 seconds, and with the model still fluttering, the motion pictures showed the initial signs of failure to be a fracture of the tip rib and tearing of the adjacent skins just forward of the trailing edge. The piece of the tip rib tore away and was followed by tearing away of pieces of skin and the top part of the solid trailing-edge member. This was followed by further tearing of both skins in the next-to-last bay from the top of the model to about midsemispan, tearing away of an additional piece of skin and the trailing-edge member, and finally by the departure of the upper half of the next-to-last web. This last action occurred at 13.5 seconds by which time the entire upper rear corner had torn away. From about 13.5 to 14.2 seconds the model experienced additional disturbances associated with the shutdown characteristics of the jet. The failing action just described is illustrated in figure 12 by six frames taken from the motion pictures, and the model after the test is shown in figure 13.

The primary cause of failure was the aerodynamic heating since the model survived the starting disturbances without damage and then remained steady until the induced thermal stresses reduced the effective stiffness of the model (ref. 9) and caused it to flutter. At approximately the same time that the model began to vibrate, chordwise buckling of the skin developed in the rearmost bay; however, the exact order of flutter and skin buckling cannot be stated with certainty. The flutter could have been caused directly by thermal stresses which were insufficient to produce buckling but which were nevertheless sufficient to reduce the effective stiffness of the model to a point where flutter occurred, or the thermal stresses could have caused skin buckling (also a reduction in stiffness) which triggered off the model flutter. In either event the primary cause of failure was the aerodynamic heating. The flutter that

Although the preliminary results of reference 2 indicated that the flutter of model MW-2 was induced by thermal buckling of the skin, the more extensive study of the motion pictures and the strain-gage records reported herein reveals that it is impossible to state positively the order in which these events occurred. The skin buckle in the rearmost bays (each side) developed gradually (and may also have been developing to a lesser extent in other bays), so that it is impossible to assign an exact time of buckling; hence, the time given (10.0 seconds) is that when an obvious buckle had developed. The wire strain-gage records reveal more definitely that at 9.8 seconds, approximately the time of skin buckling, the model began to flutter as already described.

The failures of model MW-2 and its larger scale original model MW-1 were fundamentally similar in that flutter, either accompanied by or closely preceded or followed by skin buckling, resulted in failure in the vicinity of the trailing edge. The primary cause of failure in both tests was aerodynamic heating. The thinner skin of model MW-2 caused its skin to become hotter faster than the skin of model MW-1, and the hotter skin and smaller webs of model MW-2 also resulted in higher interior

Figure 12.- Progressive failure of model MW-2.

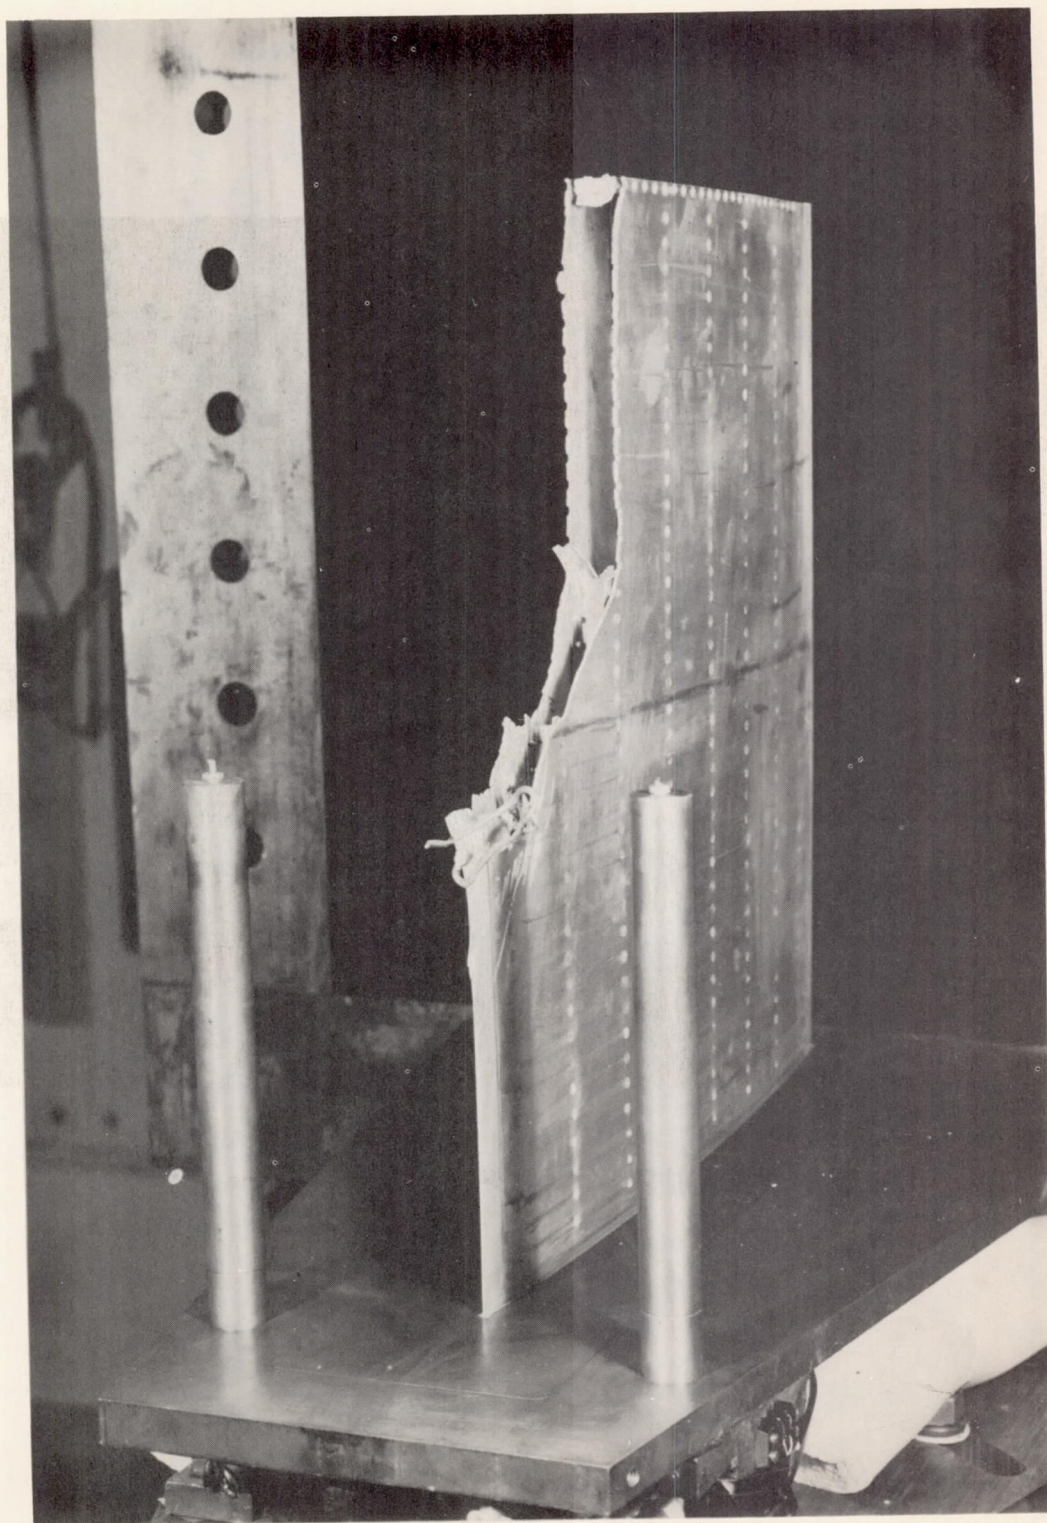
L-77204

Figure 13.- Model MW-2 after test.

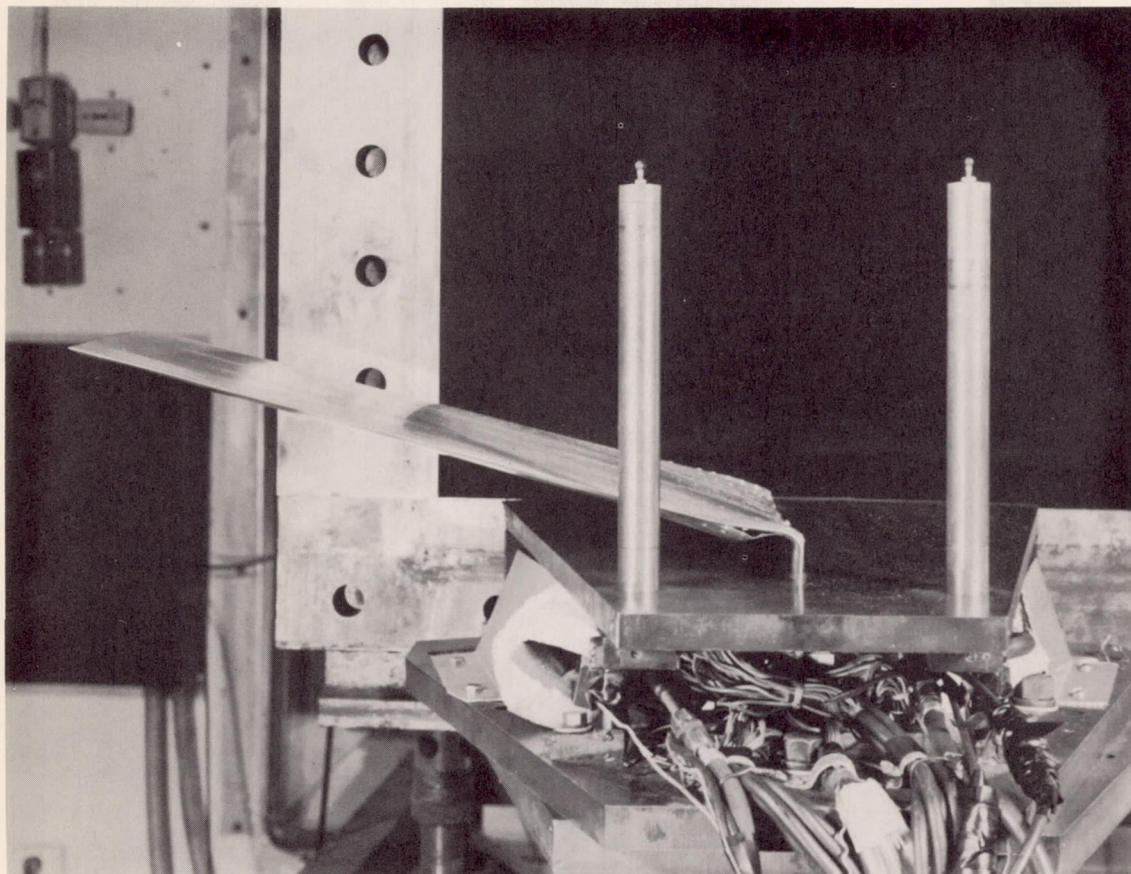
Model MW-3.- Beginning at 0.2 second after the air began to flow through the jet, model MW-3 (at an angle of attack of 5°) vibrated, mainly in bending, at approximately 65 cycles per second until the initial normal shock reached the leading edge of the model. At this time, 1.0 second, the model steadied. The normal shock wave had moved to the model midchord at 1.2 seconds, then moved downstream and disappeared. The model continued to remain steady until 1.8 seconds, at which time test conditions had been reached and the aerodynamic forces had become sufficiently large to produce compressive buckling of the skin at the root section. At this time the model collapsed on its side to the position shown in figure 14.

The failure was almost entirely independent of any aerodynamic-heating effects, since the maximum measured temperature rise (70° F) was insufficient to produce any noticeable changes in the properties of the material and the temperature differences in the structure (approximately 35° F near the middle of the model) were so small that only negligible thermal stresses had developed. Thus the failure was almost solely due to aerodynamic loading. At the time of failure the aerodynamic forces had increased to slightly beyond the prescribed value ($H = 106$ lb/sq in. abs), and the calculated force of about 6.7 lb/sq in. (970 lb/sq ft) was sufficient to cause the skin to wrinkle completely across the chord and to crush the webs on the compression side of the model. As soon as the skin wrinkled the aerodynamic forces pushed the model completely over on its side.

Figure 14.- Model MW-3 after failure. L-77699
